Petko Slavov *, Peter Stoinov **

EXPERIENCES WITH MONITORING OF LANDSLIDE IN SOFIA'S SUBURBS OF FILIPOVTSY

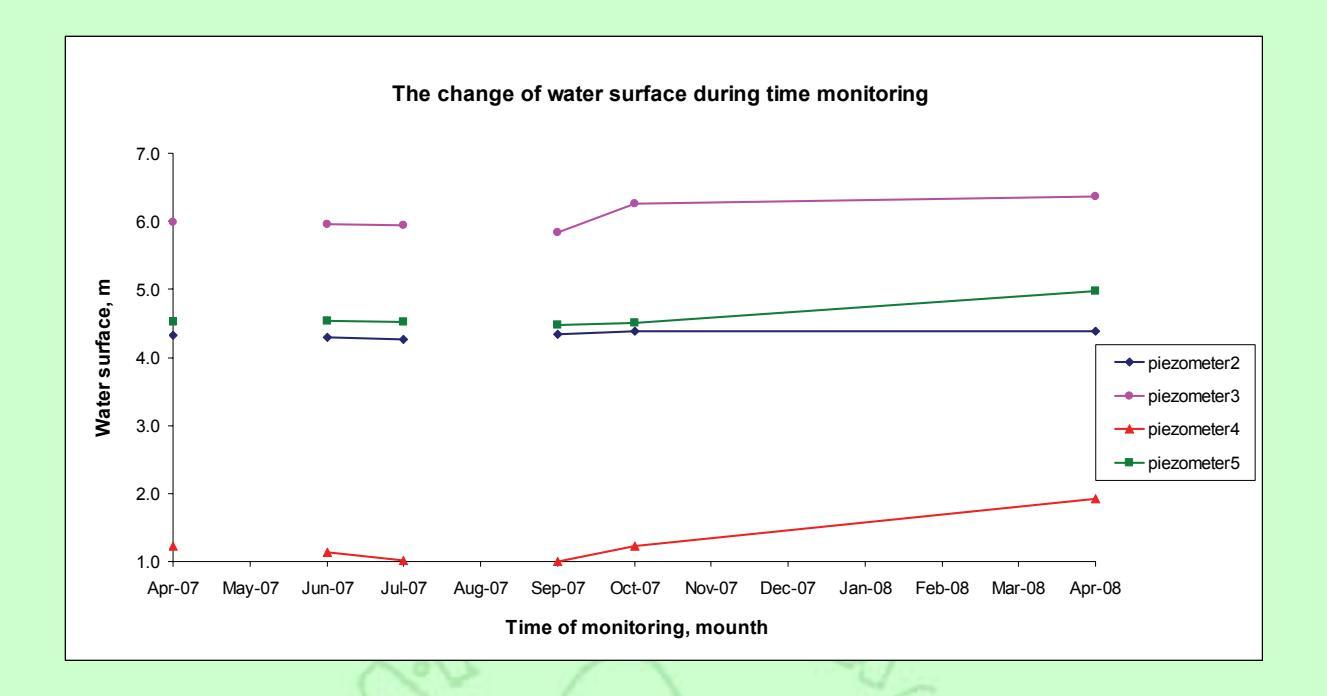
As a whole, no significant change is observed in the piezometer water level (attached diagram of water surface/time of monitoring) – obviously the drainage facilities are effective.
